ARCHAEOLOGICAL MONITORING REPORT

SCCAS REPORT No. 2013/105	Parish: Badley
Badley Hall, BADLEY	Planning application no: 0791/05
	HER Event No: BAD 009
	<i>OASIS ref: suffolkc1-156721</i>
Address: Badley Hall, Badley, Suffolk.	Grid reference: TM 0602 5584
	Number of site visits: 1
	Date of visits: 7th August 2013

Nature of the work: Excavation of a service trench to the rear of the Badley Hall, part of a substantial medieval hall complex.

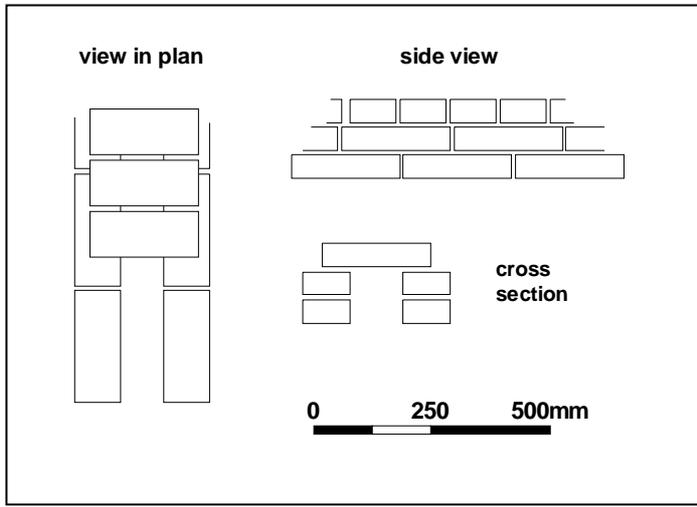
Figure 2. Measured drawing showing approximate construction of the brick-built drain

Approximately central to the trench was a brick built drain, constructed as shown in Figure 2 and of the same bricks described above (Plate 5).

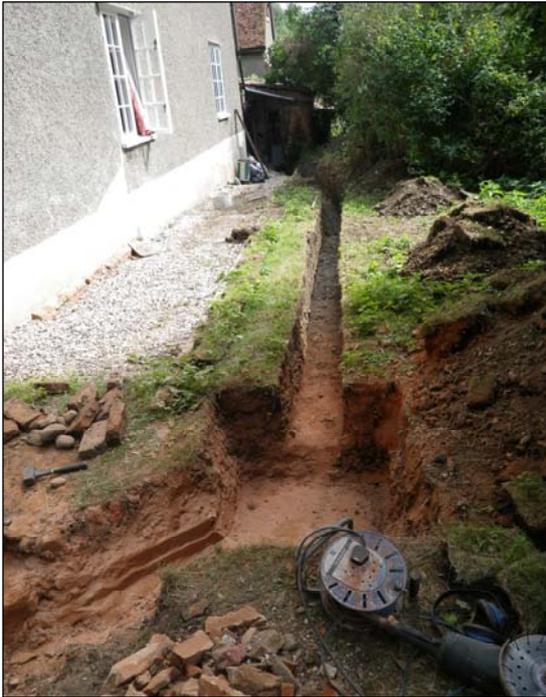
Plate 1. General view of the service trench, looking SE

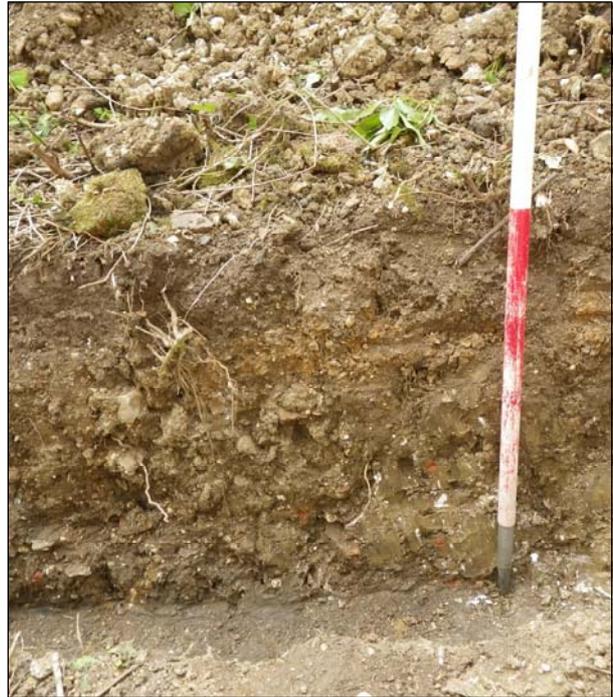
The trench measured 0.4m wide except at the northern end where it opened to a square measuring approximately 1m and was up to 0.6m in depth. It was excavated through c.0.2m of dark brown clay loam topsoil with regular chalk flecks and up to 0.4m of made-up ground (Plate 2). This mixed layer consisted of a mid brown chalky clay and topsoil matrix with regular brick and tile fragments, oyster shells, flint pebbles and chalk lumps and flecks. Lenses of coarse sand and charcoal flecks were also noted. Throughout the base of the trench, a mid orangey brown clay was observed, assumed to be the natural subsoil.

Plate 2. Soil profile

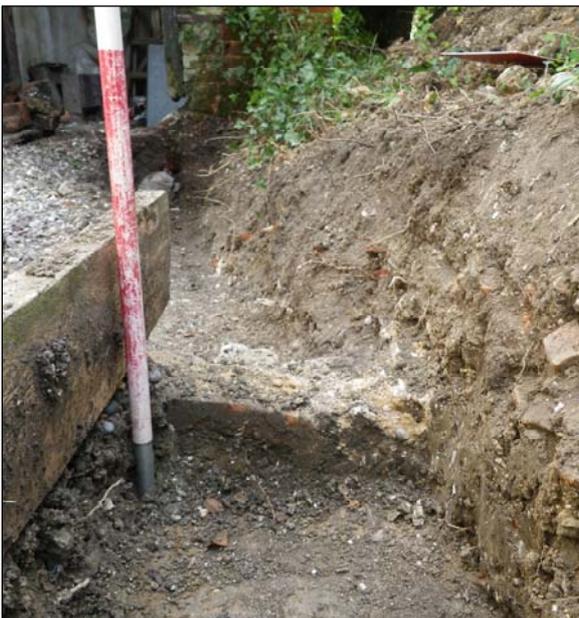
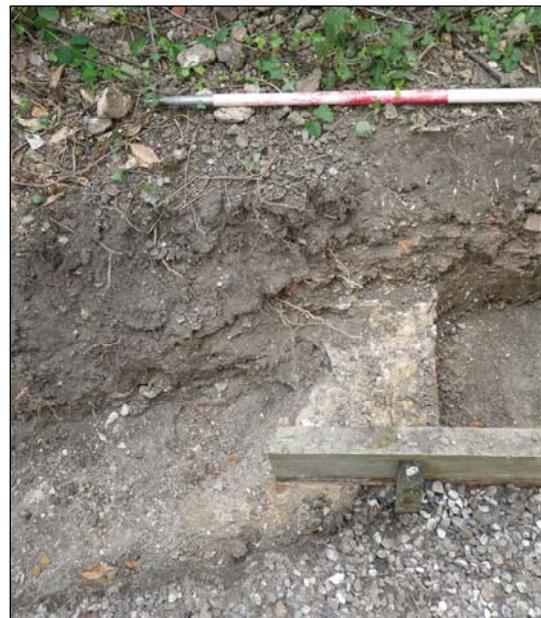
At the southern end of the trench, remains of a SW-NE aligned wall were noted in the form of a brick and lime mortar footing (Plates 3 & 4). It measured approximately 0.5m wide, was constructed of narrow, probably late medieval or early post-medieval, red bricks and was well faced on the north side but its south side was heavily damaged. It shares the same alignment as the hall and extant garden walls.

Plate 3. Southern wall remnant, looking SE

Plate 4. Southern wall remnant, from above

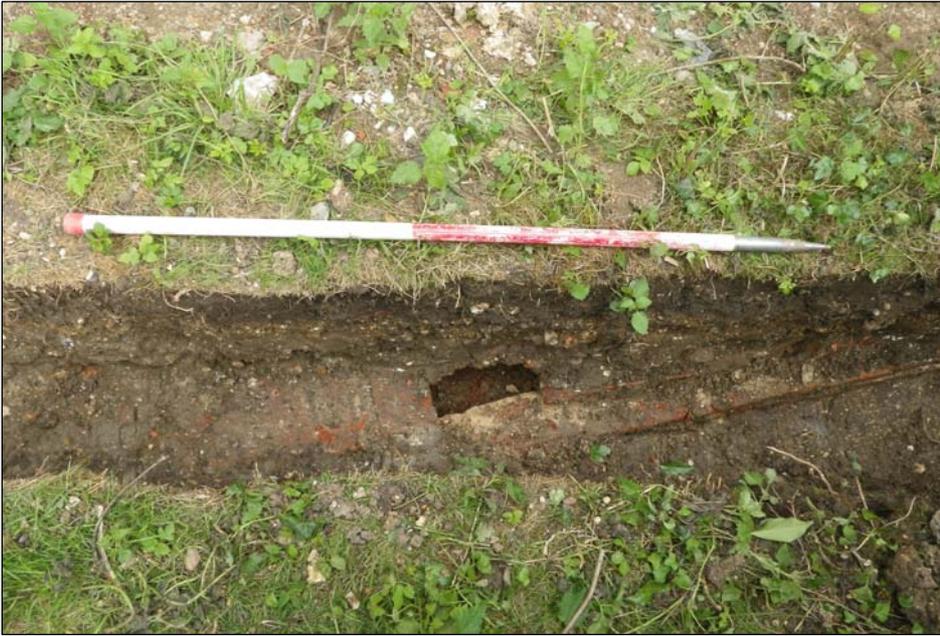
Plate 5. Brick built drain, from above

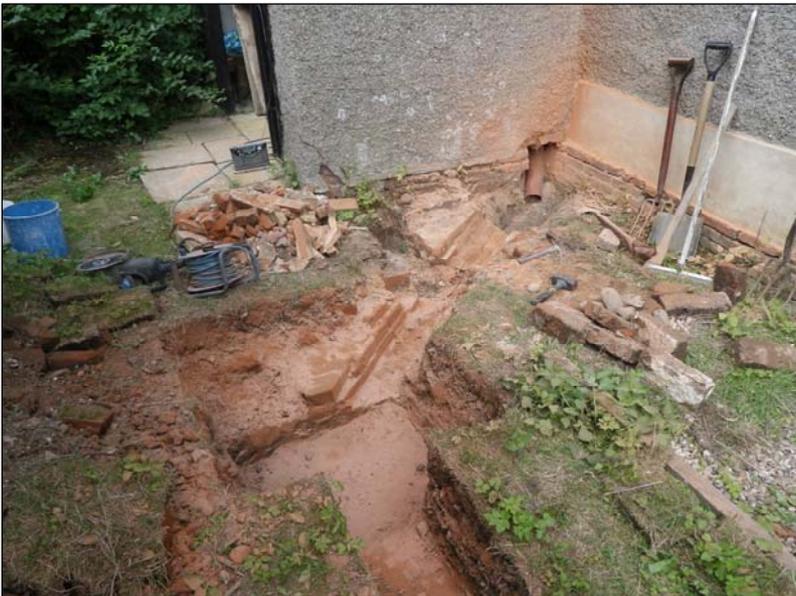
Brick footings in the northern end of the trench (Plate 6) appeared to represent the continuation of an extant SW-NE wall with a 90° northern return up to (and incorporated in) the porch (Plate 7). It was constructed from the same bricks as previously described, bonded with a lime mortar and at the foot of the northern side of the wall, a brick built drain of similar form to that observed in the centre of the trench was noted. The wall and porch are shown on the first edition Ordnance Survey map dated 1885 but a porch is not present on a plan of the hall complex dated 1741.

Plate 6. Brick footings in the north end of the trench, looking N

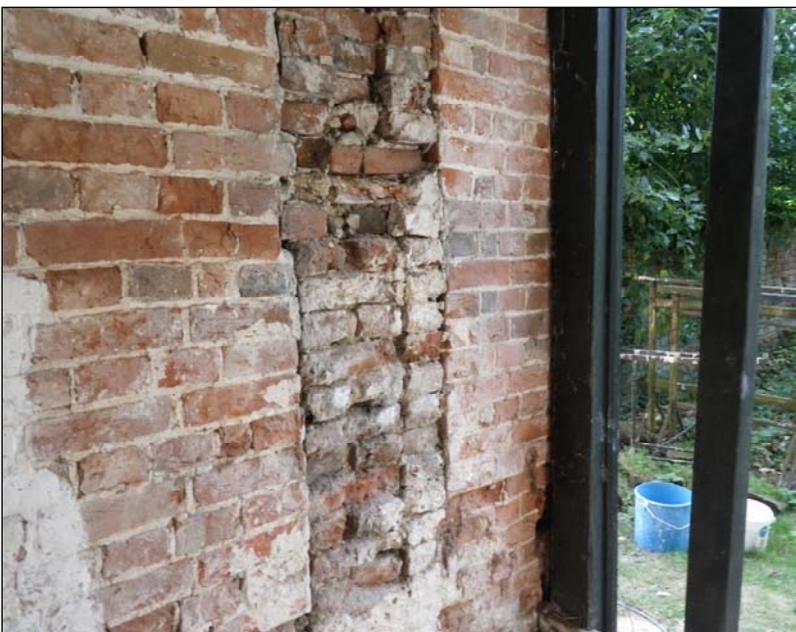
Plate 7. Northern wall remnant incorporated into the fabric of the porch. Looking S from inside the porch
