**Interim Visitor Centre  
Landguard Viewing Area, Felixstowe  
FEX 310**

**Archaeological Monitoring Report**

**SCCAS Report No. 2013/010**

**Client: Port of Felixstowe**

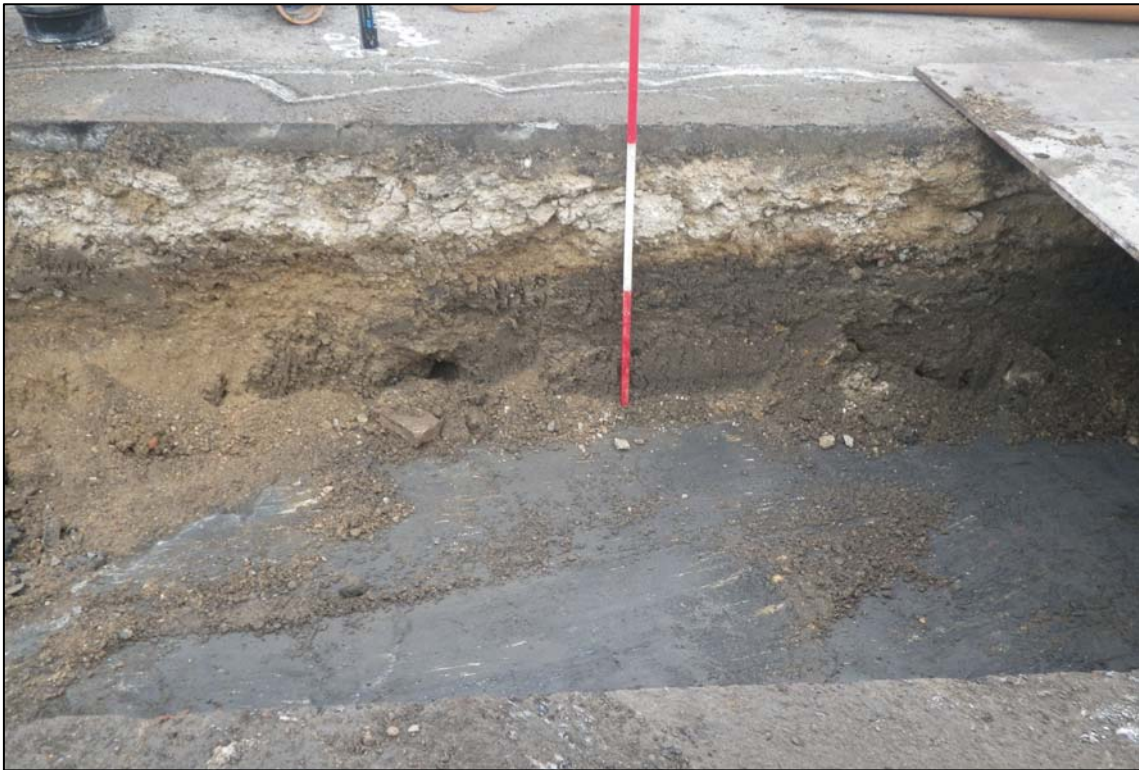
The only archaeological evidence of any significance was noted in a north-east to south-west trench located outside the footprint of the proposed centre. It comprised a large concrete slab bounded by brick walls and was interpreted as the remains of a building (Fig. 3). The concrete slab, which lay a depth of 1m below the present ground level, was 0.13m thick with a smooth upper surface and was interpreted as the building's floor (plate 1). No evidence for any other flooring overlying the concrete was noted.

on the upper face of the brick wall, level with the floor, to provide a barrier to reduce damp (visible in plate 1). A similar wall was identified further to the north-west where it clearly formed a corner to the building (plate 3). The height of the walls had been reduced to the level of the concrete floor.

Plate 1. Concrete floor at west end of the building, camera facing north-east (ref. HSS 03)

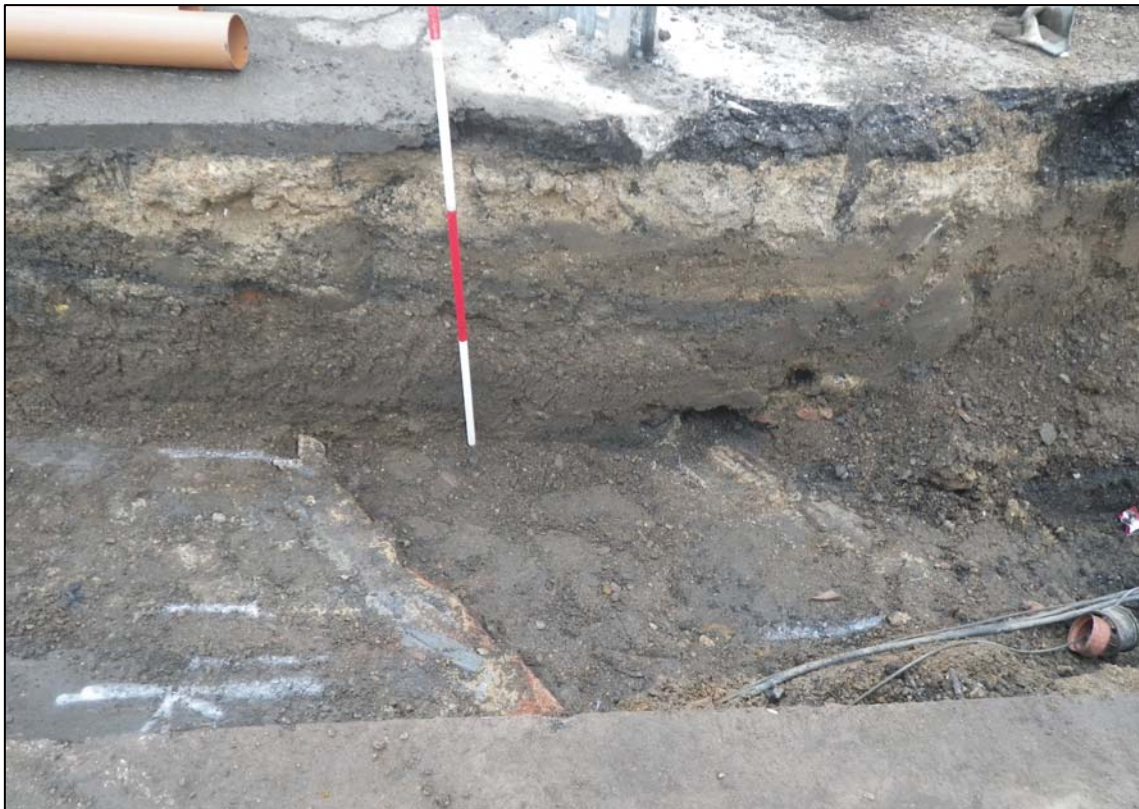
A brick wall ran along the slab's eastern edge (plate 2). It was 0.22m thick and built of hard pink bricks (22cm x 6.5cm x 10cm) with a hard cement. A layer of slate was visible

Plate 2. Eastern wall of the building, camera facing north east (ref. HSS 07)

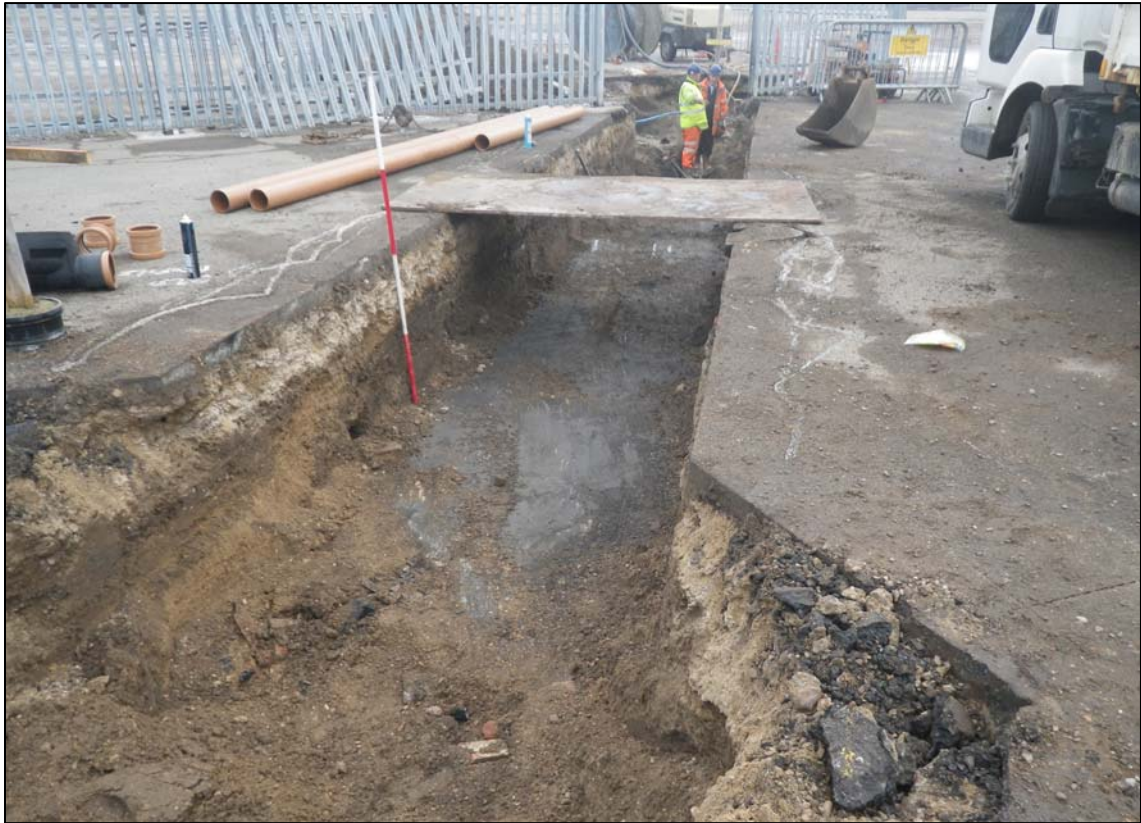
Plate 3. West end of the building, camera facing south east (ref. HSS 04)

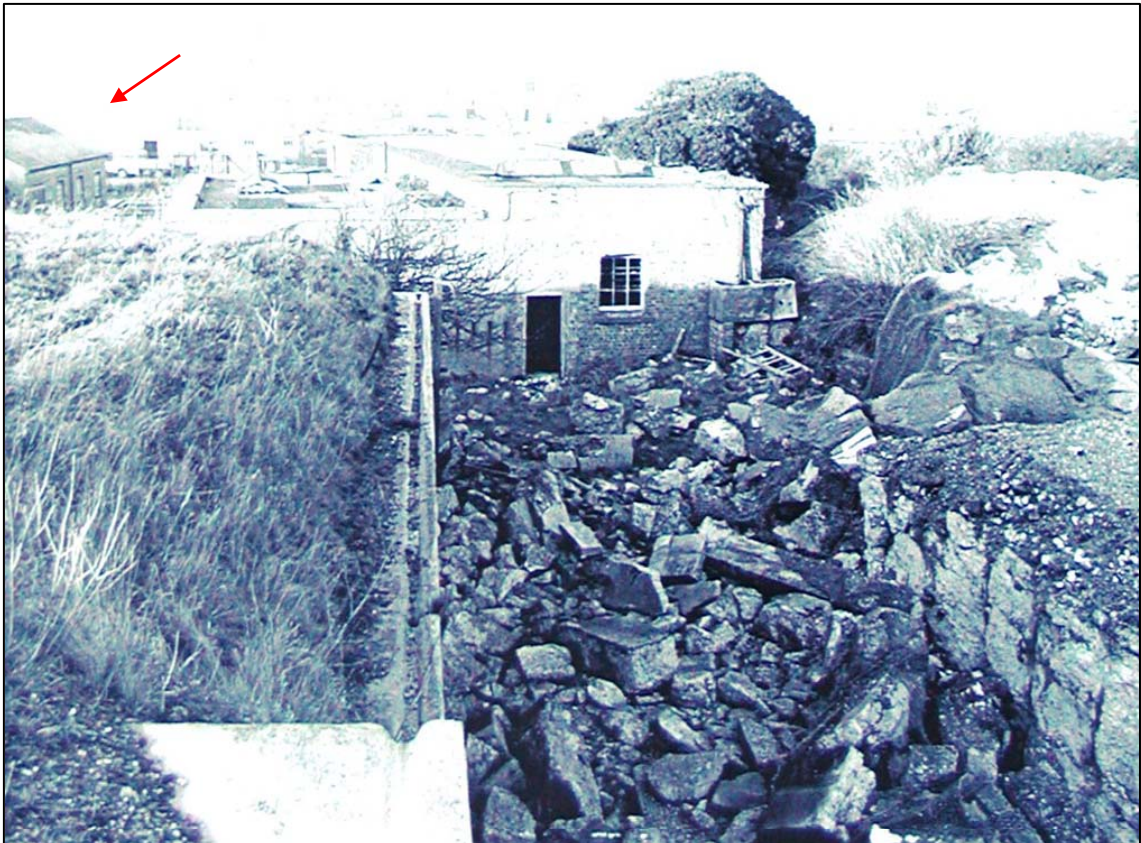
A photograph, showing this area prior to its final clearance in advance of the construction the port facilities, partially shows what may be this building (plate 4). It appears as a single storey structure with windows and an apex roof running

longitudinally. There are few obvious clues as to its purpose although documentary research should be able identify its use.

Plate 4. 1972 photograph of the Submarine Mining Establishment, camera facing north. Building identified in trench marked with a red arrow (source unknown)
