Land off Church Lane  
Barton Mills  
BTM 057

**Archaeological Evaluation Report**

**SCCAS Report No. 2013/047**

**Client: DCH Construction**

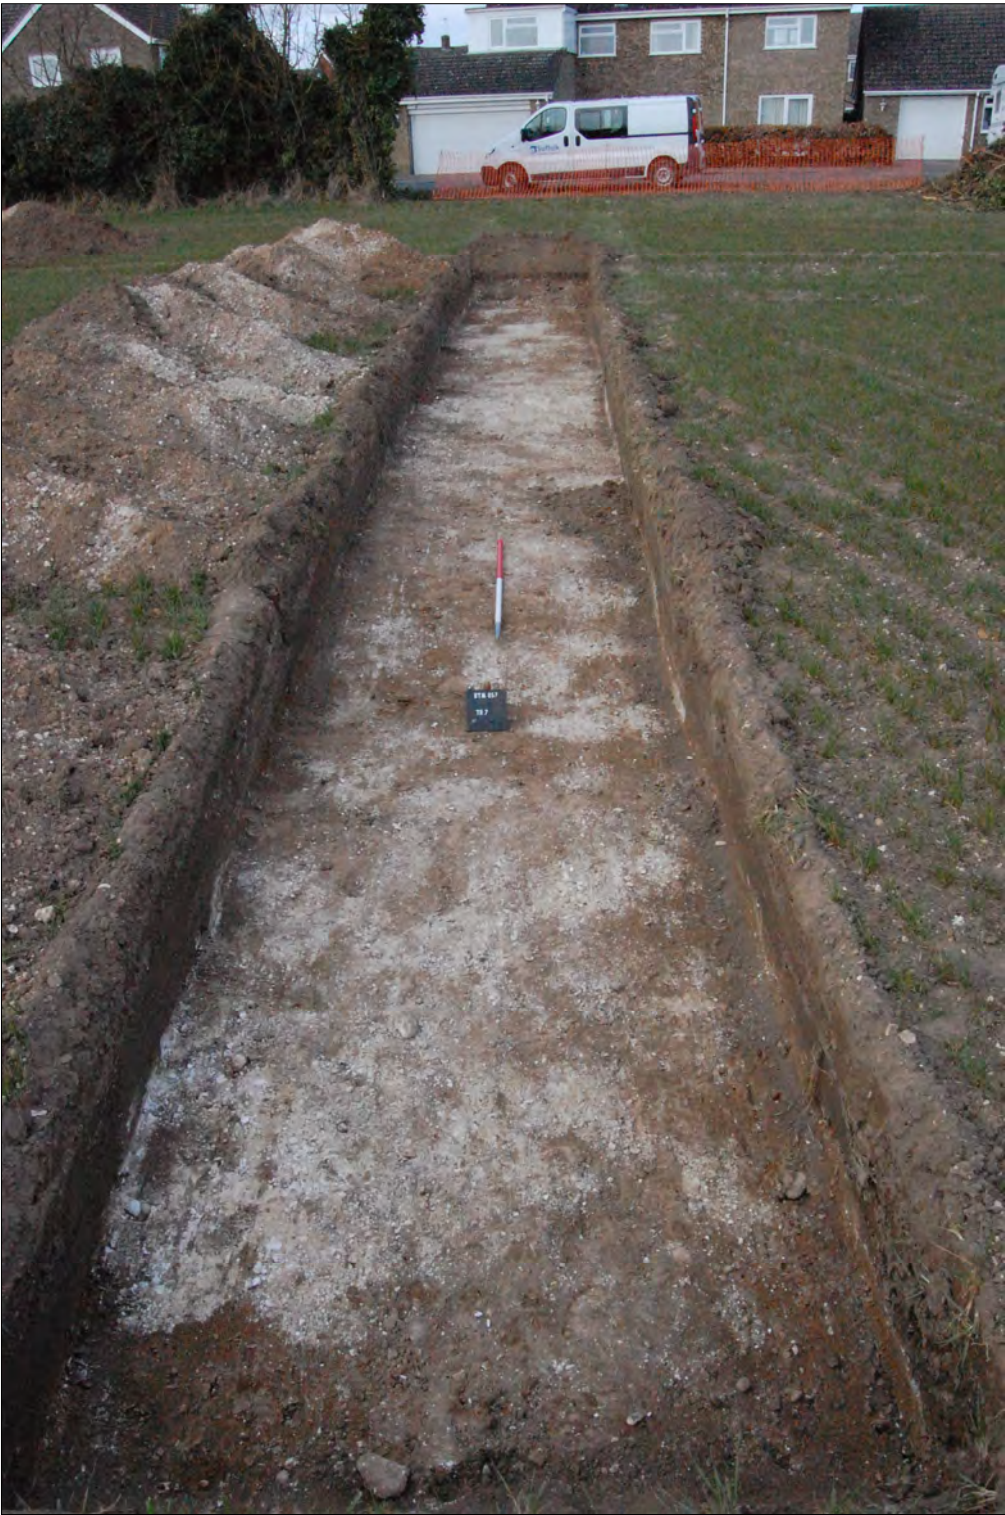
Frequent irregularly shaped hollows were identified within the natural chalk and were filled with a greyish-orangey-brown silty-sand (Pl. 1). Several of the hollows were investigated and found to have irregular morphologies indicative of natural solution hollows.

Plate 1. Trench 7 facing west, 1m scale

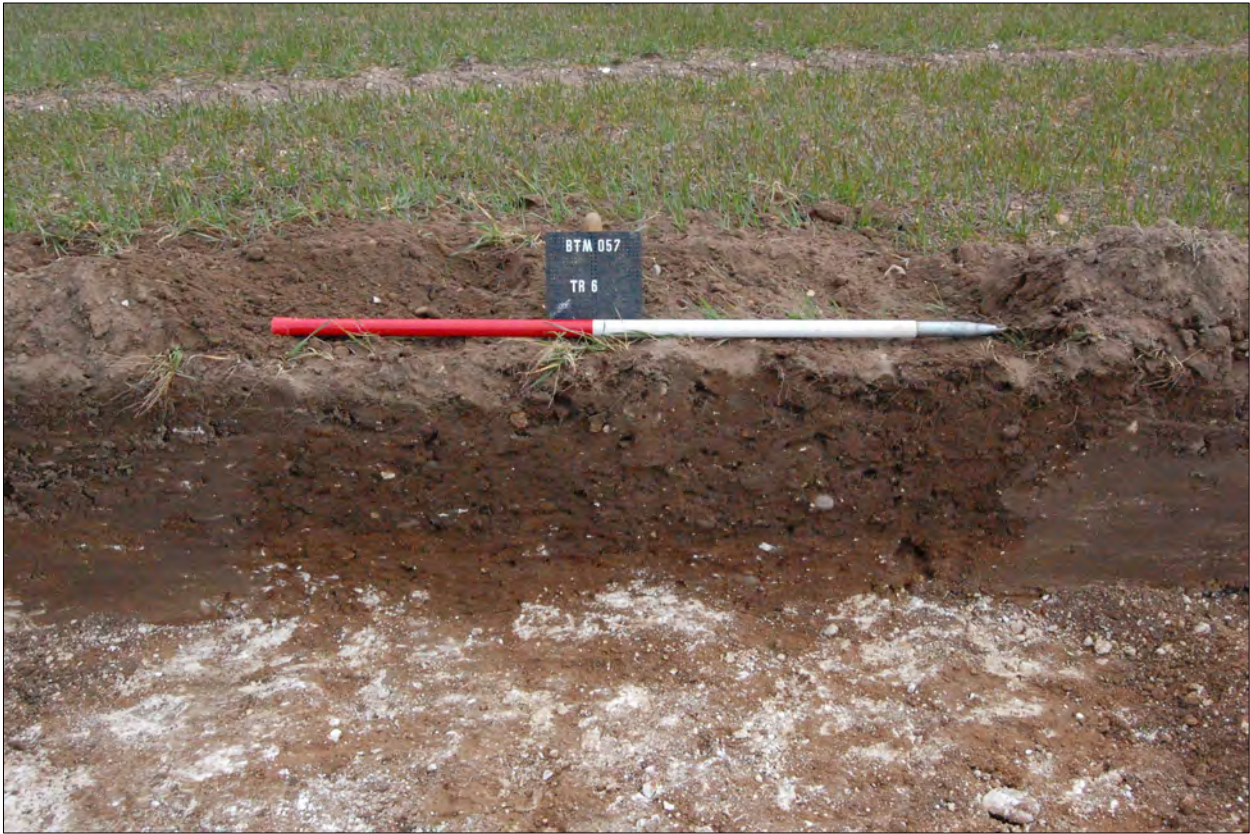
Plate 2. Trench 6 sample section. Facing south, 1m scale
