ARCHAEOLOGICAL MONITORING REPORT

SCCAS REPORT No. 2013/090	Parish: Mildenhall
Extension to the rear of Shrubland House, Mildenhall MNL 695	Planning Application No.: F/2009/0412/FUL
	OASIS No. C1-153915
	HER Event No.: MNL 695
Address: 2, King Street, Mildenhall	Grid Reference: TL 711 747
	Number of Site visits: 2
	Date of visits: 13/14 June 2013

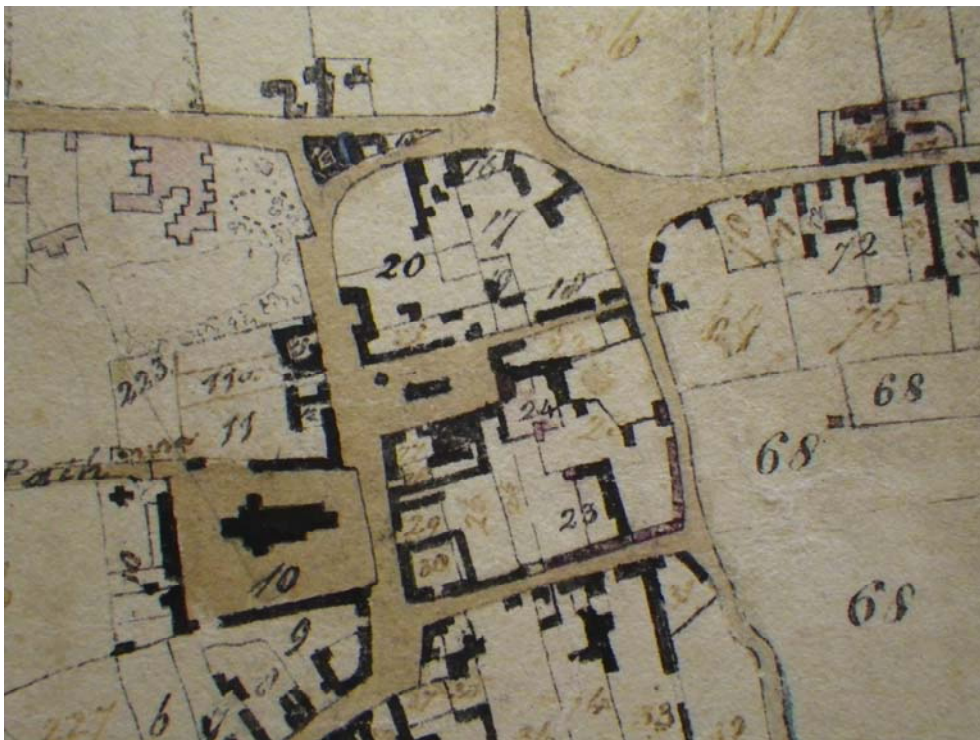
W.H. Youngs' Map of Mildenhall 1834 shows the house with additional ranges (no longer extant) attached to the front of the building (RO ref EF 505/1/82)
